Demolition Certificate of Approval  
Supplemental Application (Misc. Resource/Accessory Structure)

1234 Hawthorne Street  
ALAMEDA, CA 94501

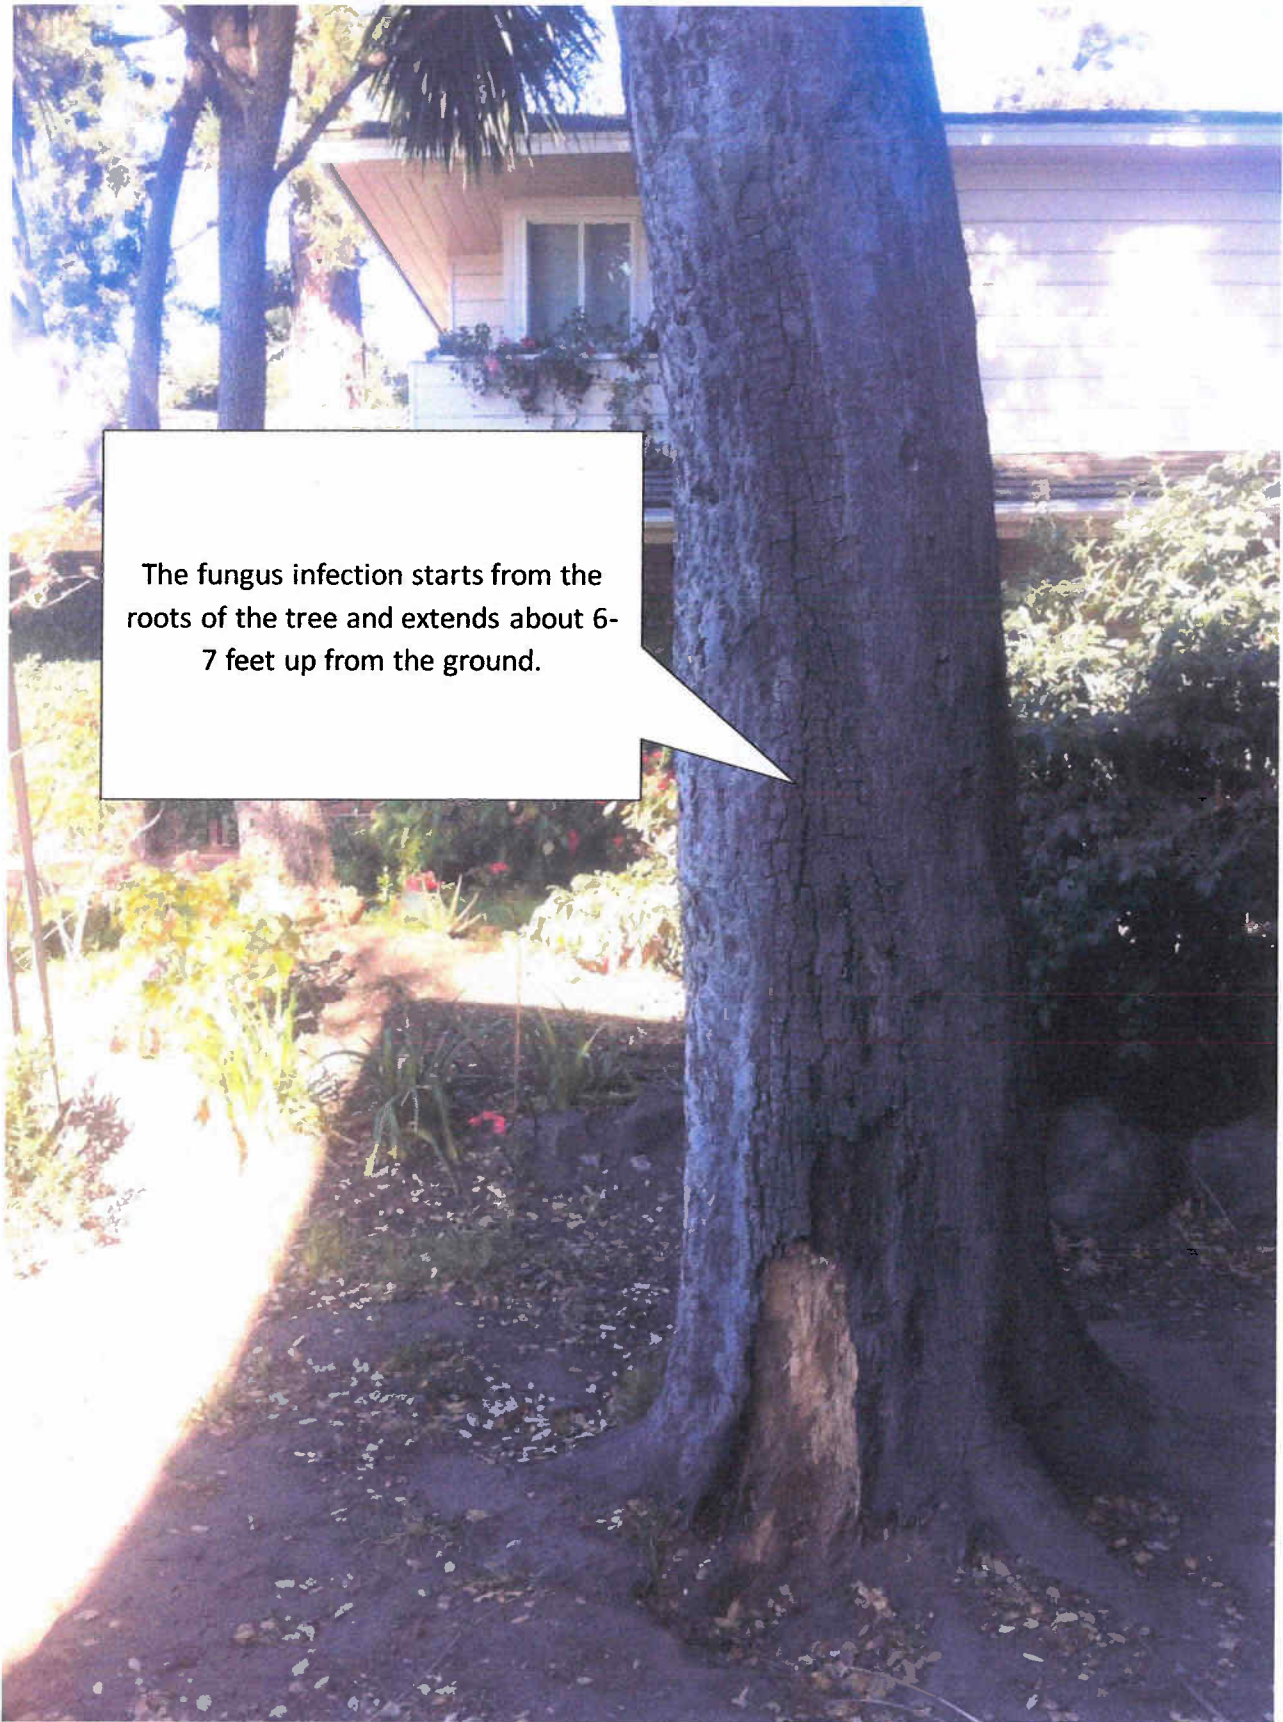
The fungus infection starts from the roots of the tree and extends about 6-7 feet up from the ground.

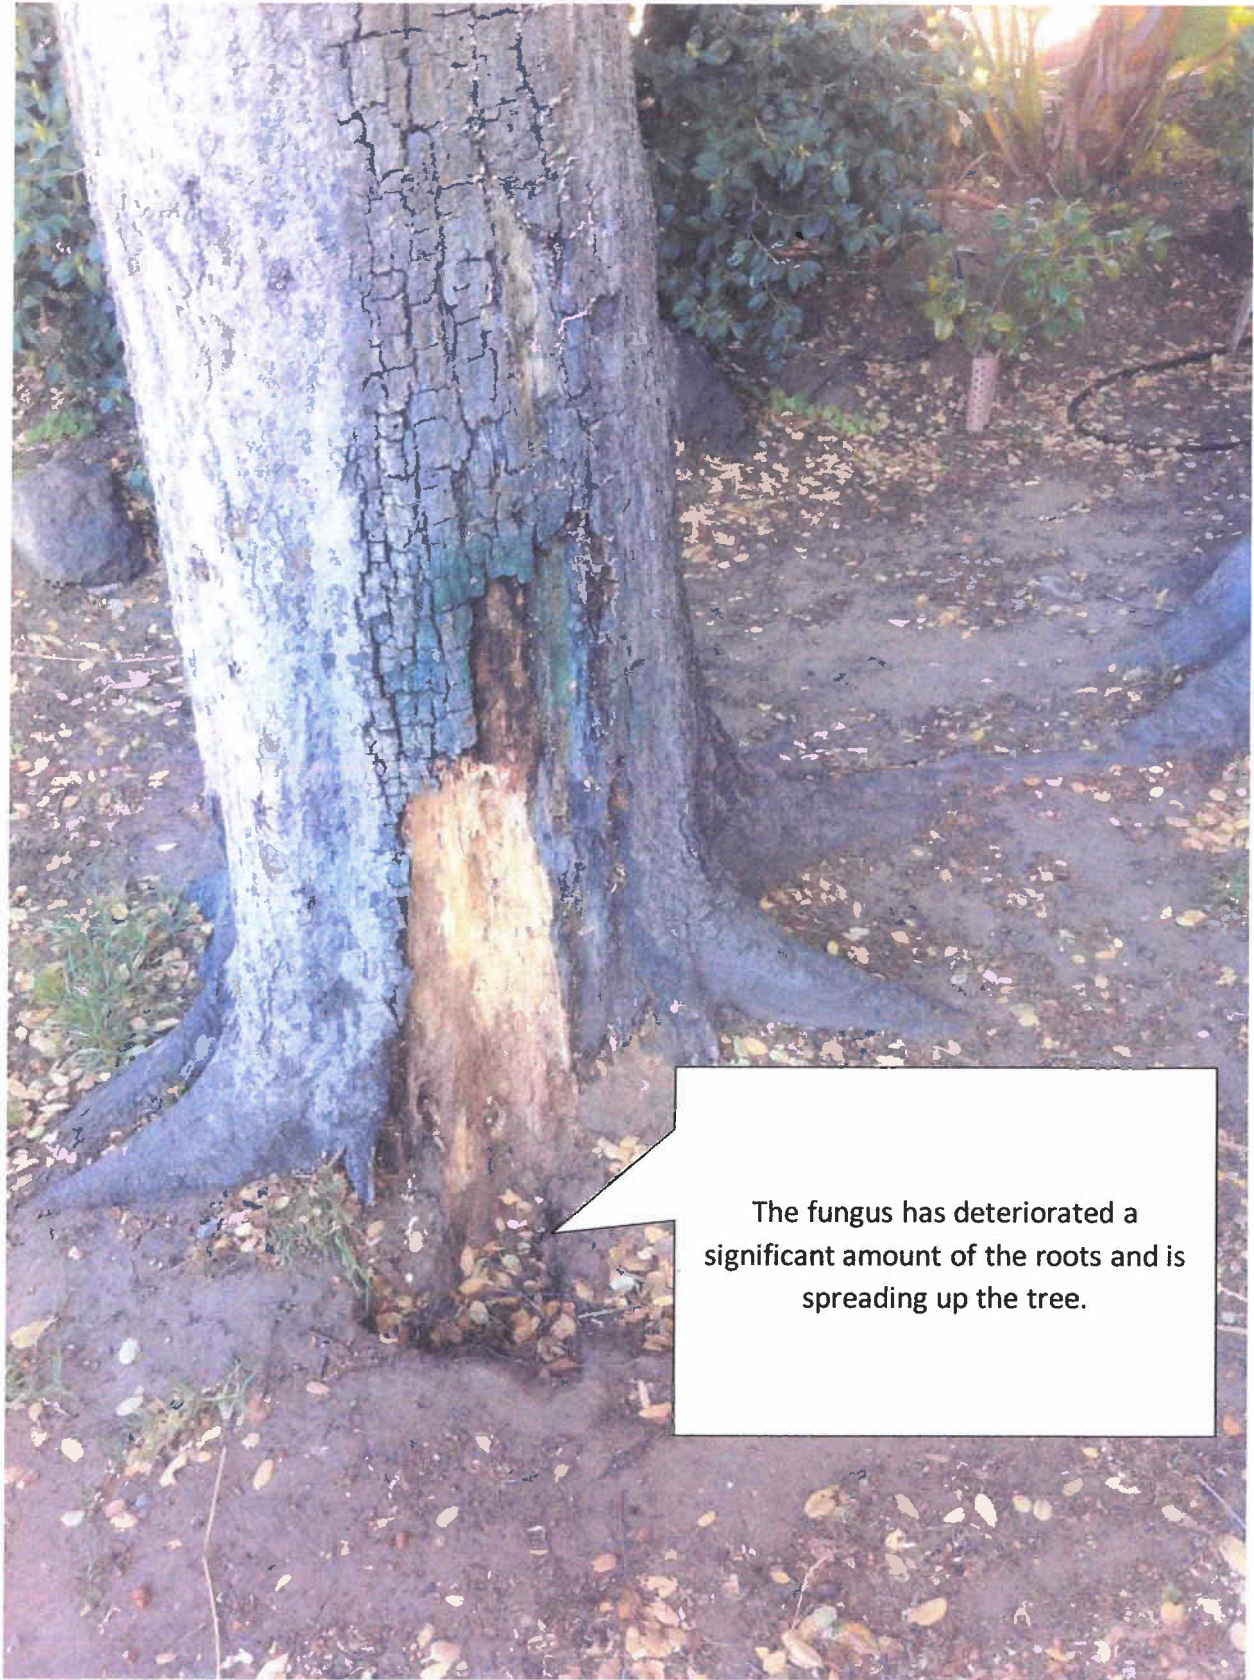
The fungus has deteriorated a significant amount of the roots and is spreading up the tree.

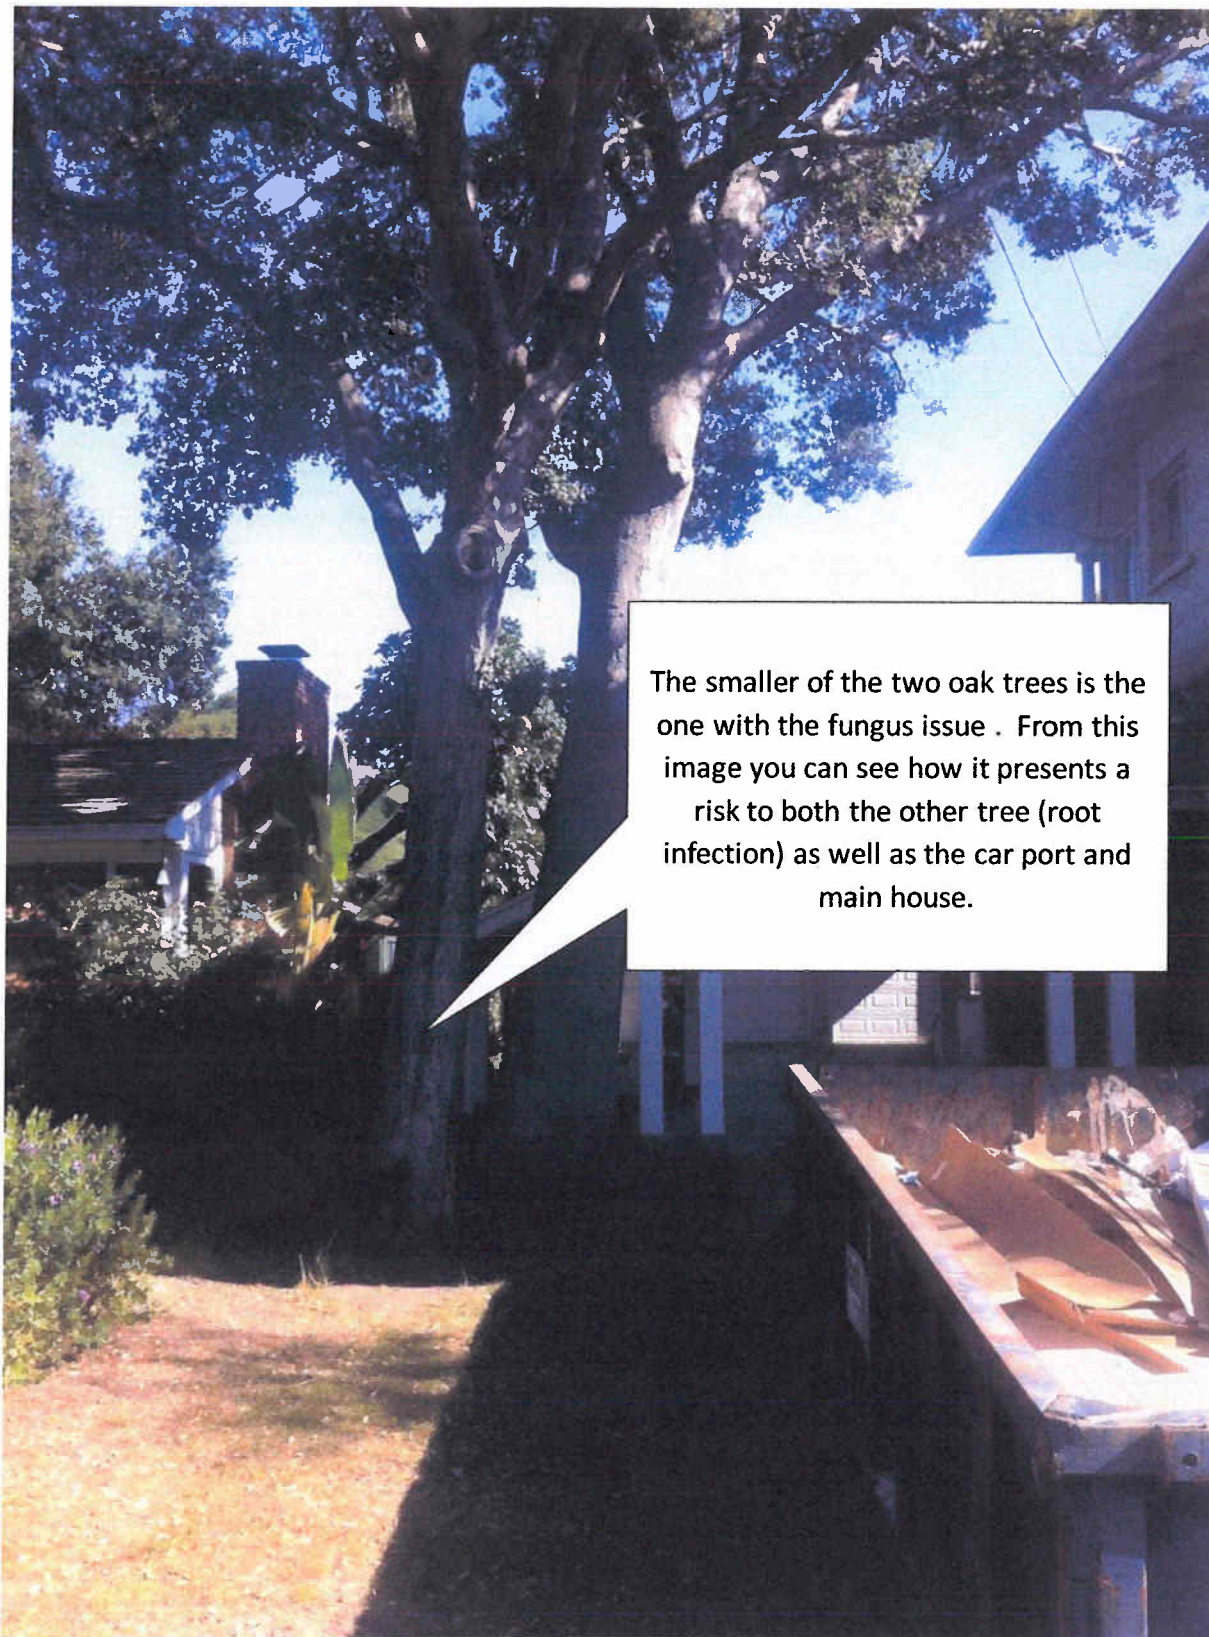
The smaller of the two oak trees is the one with the fungus issue . From this image you can see how it presents a risk to both the other tree (root infection) as well as the car port and main house.
